Manhole Inspection Summary

Manhole # S27M__030MH

Insp Date: **5/2/08 11:12 AM**

Location Address: **1142 Washington BD (behind)**

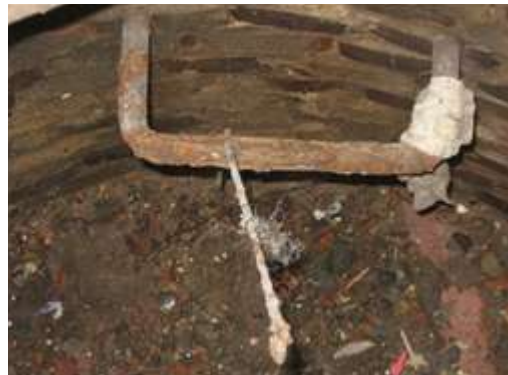
Defect 5

Surcharge ☒ **Evidence Of Surcharge** Depth: **1.5** (ft.) ☐ Active Surcharge Present

evidence of surcharge

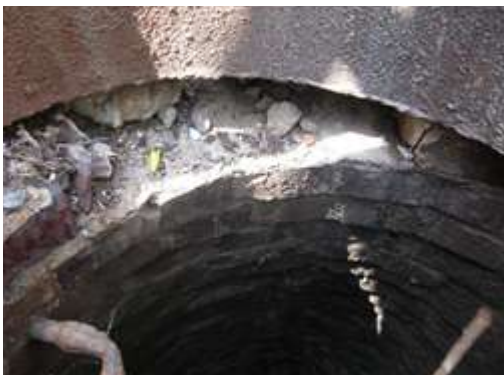
Defect 4

Condition: ☐ Sound ☐ Cracked ☐ Root Intrusion ☒ **Loose Brick** ☒ **Deteriorated**

Infiltration: ☐ None ☒ **Joint** ☐ Cracks ☒ **Mortar** ☐ Roots ☒ **Wall**

chimney cond deteriorated, chimney joint, chimney cond loose bricks, chimney mortar

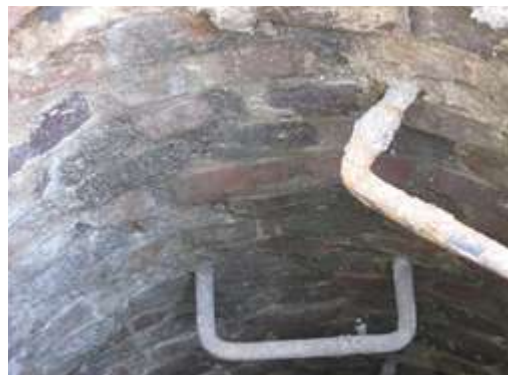
Defect 3

chimney flow wall

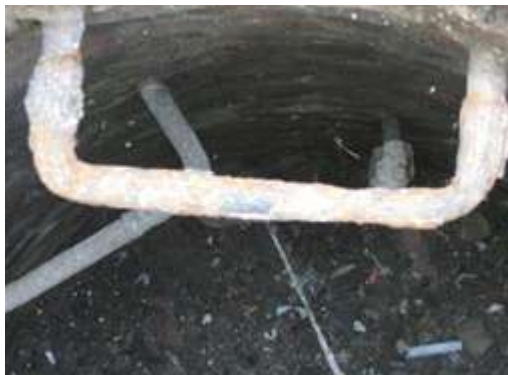
Defect 2

Steps Count: **2** Missing: **0** ☒ **Corroded**

corroded steps

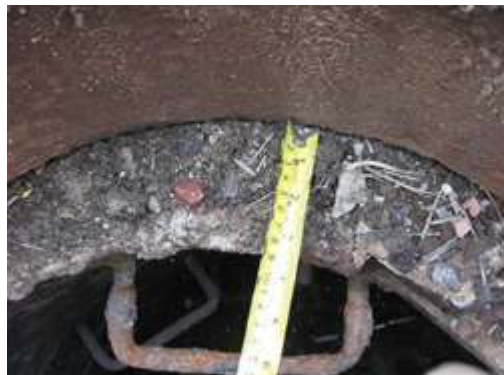
Defect 6

Frame Offset: **4** (in.)

☒ **Leaks**

offset 4"
